Special issue: Materials for waste and biomass combustion

Materials performance in simulated waste combustion environments

High temperature corrosion under simulated biomass deposit conditions

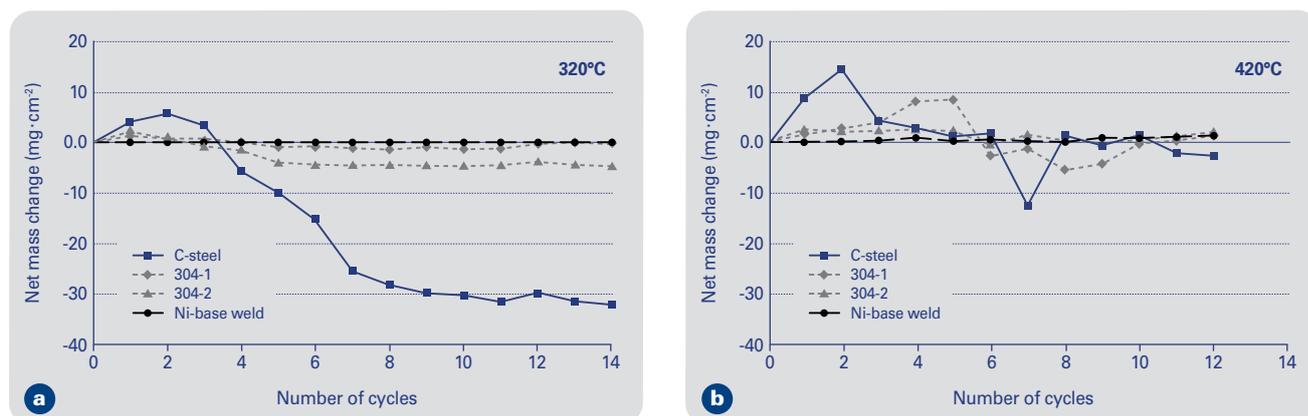
Fig. 1 Net mass change curves during exposure in the simulated waste combustion environment. The total mass of deposit applied was $\sim 10 \text{ mg}\cdot\text{cm}^{-2}$ during the course of testing.

cycle, making a total of approximately 10 mg·cm⁻² over the duration of the test. The net mass change can, however, easily be misleading since it includes several factors which counteract each other: a mass gain due to deposition and oxidation and a mass loss due to spallation and volatilisation of applied salts or metal chlorides.

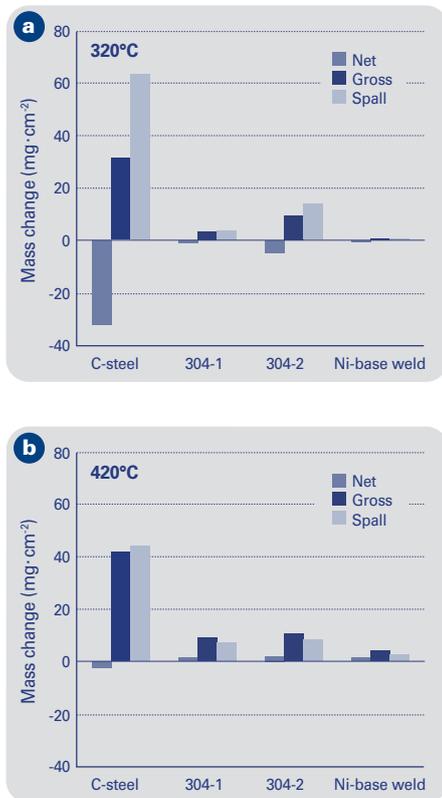
Fig. 2 Comparison between net and gross mass changes at the conclusion of testing. The amount of spall is the difference between the two.

The gross mass change, which includes both the mass of the specimen and the spalled corrosion products, is a somewhat more useful measure. Data at the conclusion of testing are given in Figure 2, and show slightly higher mass gains for all materials at 420°C than at 320°C. There is also clear differentiation between the materials. The carbon steel exhibited mass changes of over 30 mg·cm⁻². For the 304L stainless steels the figures were below 10 mg·cm⁻² while those for the nickel base overlay weld were 0.5 mg·cm⁻² at 320°C and 4 mg·cm⁻² at 420°C. Two factors mean that even the gross mass changes may be a relatively poor measure of materials performance. One is the occurrence of volatilisation, which causes a mass loss but is not possible to measure when performing testing on multiple specimens. Volatilisation may involve evaporation of the salt deposit or the formation of new volatile species such as metal chlorides or oxyhydroxides [5]. The gross mass increases for the nickel base weld are significantly lower than the total amount of applied salt, so some loss to vaporisation has undoubtedly occurred.

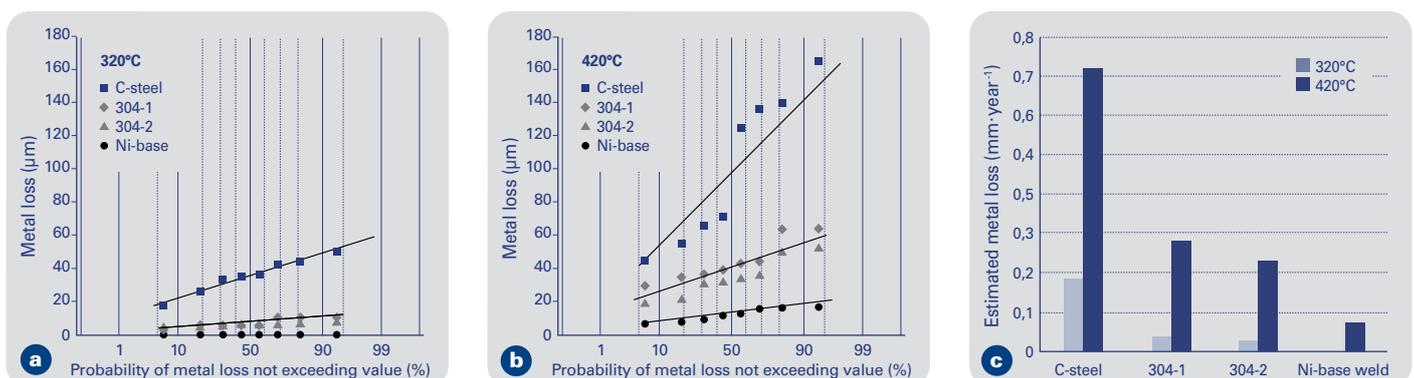
Fig. 3 Probability plots for metal penetration and maximum measured metal penetration after 14 cycles (2240 hours) at 320°C or 12 cycles (1920 hours) at 420°C.

The results of measurements on cross sections are shown in Figure 3. At 320°C the metal loss followed a normal distribution and there was no significant difference between the two heats of 304L investigated. At 420°C the carbon steel exhibited quite a high degree of scatter which could be regarded as a bimodal distribution and the two 304L variants showed slight differences. The metal loss for the nickel-base weld overlay was not measurable at 320°C; where corrosion was only apparent as a slight discoloration of the surface, but some attack was seen at 420°C.

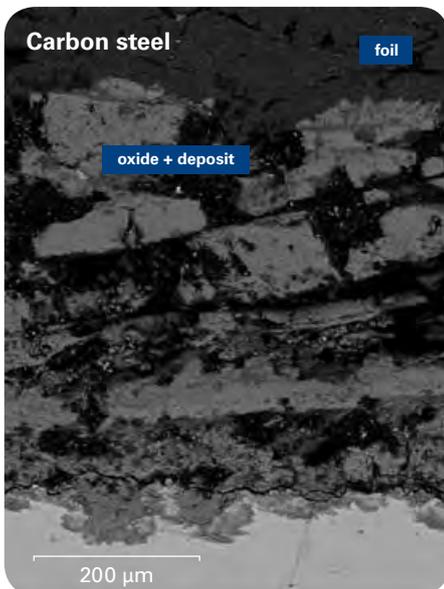
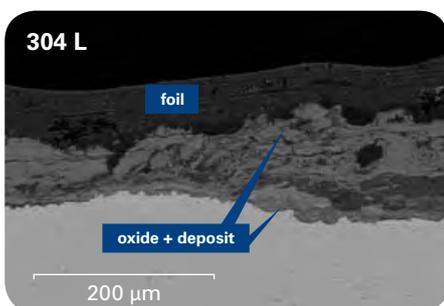
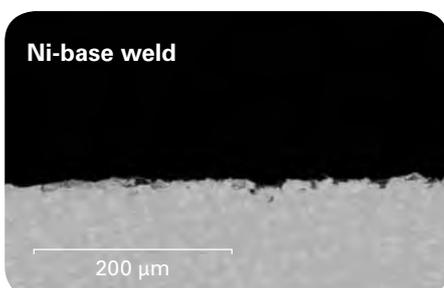
Fig. 4 Corrosion products on the three materials after testing for 12 cycles in the simulated waste combustion environment at 420°C. A foil has been used to retain the corrosion products for sectioning.

The corrosion product layers were relatively compact, as illustrated by the micrographs in Figure 4. Consequently, there is also quite good agreement between the gross mass change and the measured metal loss, with the same trends in both cases. The measured metal loss in Figure 3 can be used to estimate metal wastage rates if kinetics are known. The worst-case assumption is that the metal loss is linear, which seems reasonable in view of the non-protective nature of the corrosion products and the often large amount of spallation. This gives wastage rates of 0.7 mm per year for carbon steel at 420°C and 0.2 mm per year at 320°C. Corresponding values for 304L are 0.3 and 0.04 mm per year respectively, while the nickel base overlay weld at 420°C would lose 0.07 mm per year.

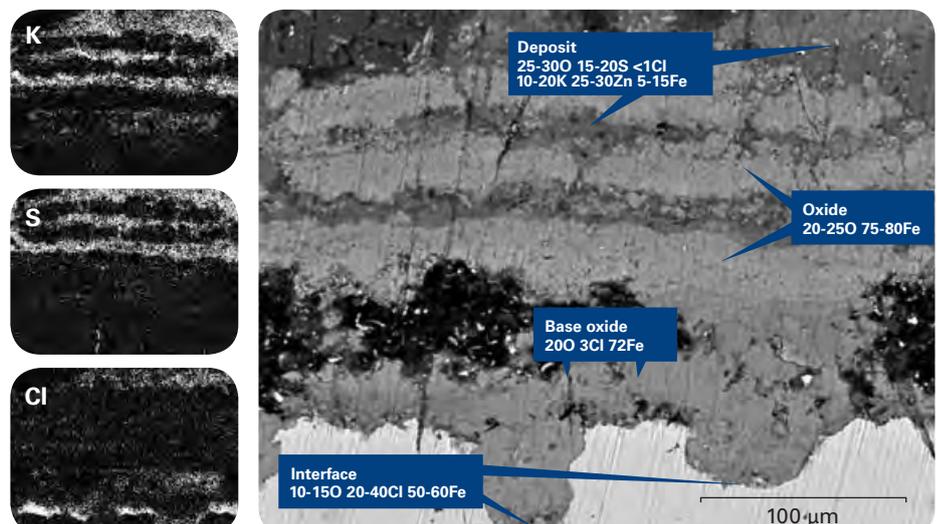
Fig. 5 Carbon steel exposed in the high temperature waste environment (420°C), showing extensive corrosion with alternating deposit and oxide layers. Cl was concentrated at the base of the corrosion layer at levels of up to 40 weight percent but was present in concentrations of <1% otherwise.

The carbon steel showed extensive spallation at 320°C but retained most of the corrosion products after testing at 420°C. These comprised alternating or irregular layers of salt deposits and oxides, as shown in Figure 5. The most interesting aspect of the deposit was that although the specimens were recoated each cycle with KCl and ZnCl₂, the deposit after testing at 420°C contained predominantly sulphur with less than 1% chlorine. The oxygen content of the deposit suggests that it comprises mainly potassium and zinc sulphates. The zinc content was highest in the outer layers of the deposits, and was partially replaced by iron at greater depth, while the potassium content showed less variation. Thermodynamic calculations, Figure 6a, based on the gas composition used in this investigation support the observation of sulphates in that SO₂ is predicted to convert to sulphates over a range of oxygen partial pressures.

The only location where appreciable levels of chlorine were observed was at the metal-oxide interface, where up to 40% Cl was seen together with 50% Fe and 10% O. All elemental compositions are given in weight percent unless stated otherwise.

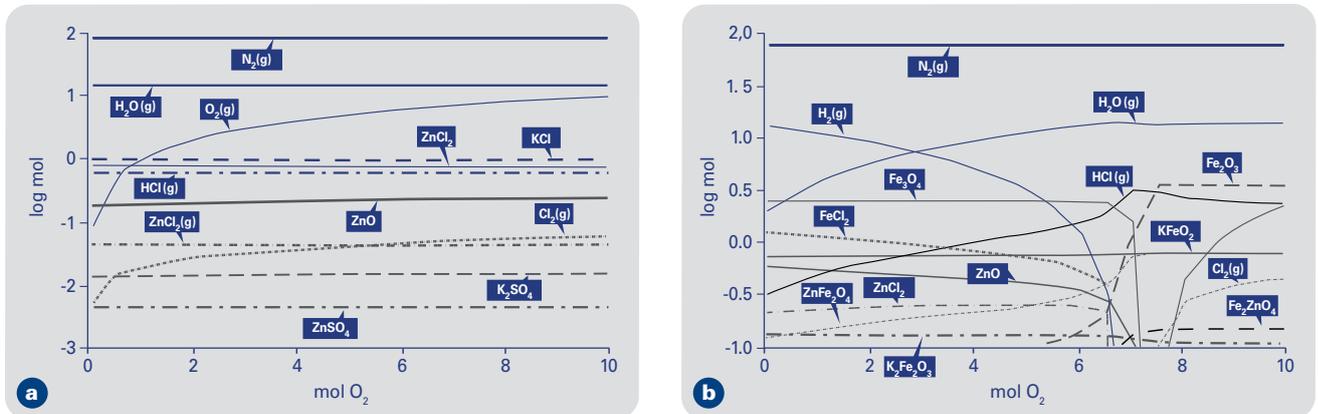
Fig. 6 Calculation of equilibrium components as a function of oxygen level at 420°C using HSC 4.1 [11] database with suspension of wüstite.

(a) 77 mol N_2 , 15 mol H_2O , 0.2 mol HCl , 0.02 mol SO_2 , 1 mol $ZnCl_2$ and 1 mol KCl showing conversion of SO_2 to sulphates.

(b) The same but with addition of 10 mol Fe showing stability of $FeCl_2$ and $HCl(g)$ as chlorine-containing species.

This is in reasonable agreement with the thermodynamic calculations in Figure 6b and observations in other works [6, 7] of the presence of $FeCl_2$ at low oxygen partial pressures. Even though particular care was taken, with dry specimen preparation immediately before examination in the SEM, iron chlorides are deliquescent and rapidly pick up moisture from the atmosphere. This is the most probable reason for the observed oxygen level. The role of this $FeCl_2$ is debated in the literature. One suggestion is the “active oxidation” concept in which volatilisation of $FeCl_2$ and its regeneration as Cl_2 plays a key role [8, 9, 10]. Another is that of “chloride catalysed oxidation” [7] in which the $FeCl_2$ has a catalytic function and only minor transport of chloride-bearing species, primarily HCl , is required. The current observation tend to support the latter since the calculations in Figure 6 predict HCl rather than Cl_2 to dominate at low oxygen partial pressures.

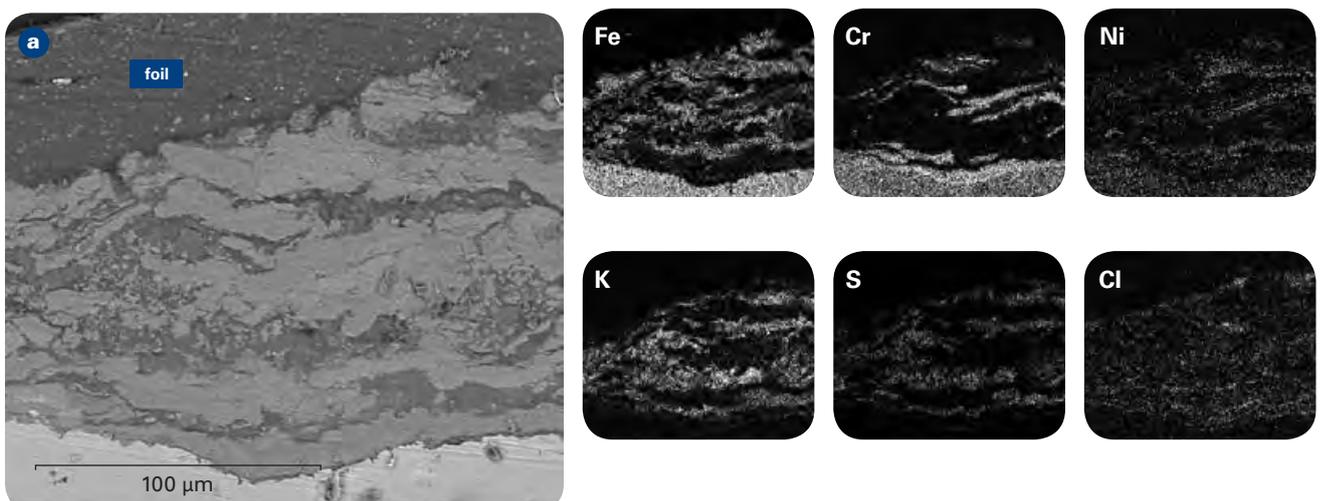
Fig. 7 Two different areas on the same 304L specimen after exposure in simulated waste combustion environment at 420°C. Corrosion products show alternating layers of deposit and oxides with some nickel sulphides. Chlorine is relatively evenly distributed through the oxide at concentrations around 1–3 weight percent.

The corrosion layers formed on 304L at 420°C, Figure 7 showed both similarities and differences compared to the carbon steel. There was a similar layered structure comprising potassium-zinc sulphates with an increasing iron content and decreasing zinc content

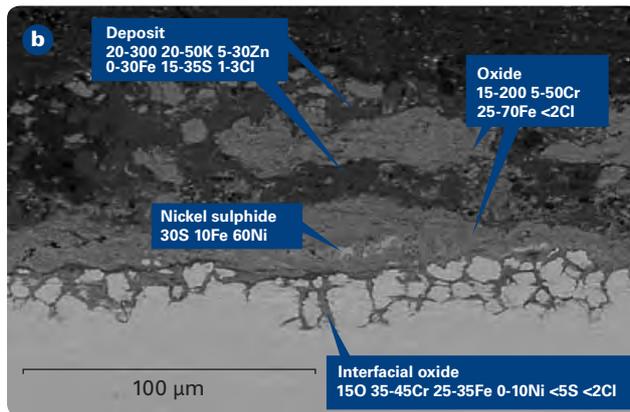
Fig. 7b Corrosion products on 304L after exposure in the simulated waste combustion environment at 420°C.

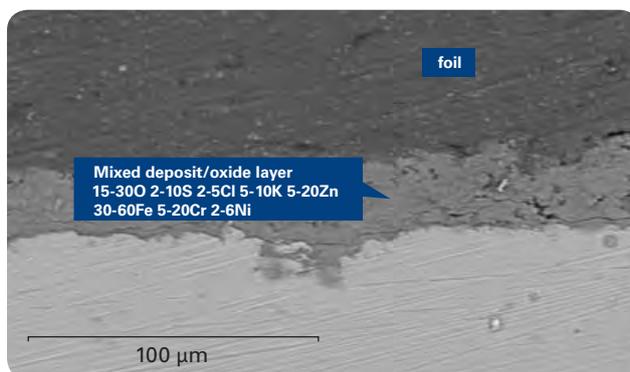
Fig. 8 304L exposed at the lower temperature of 320°C for 14 cycles. In this case there was a single oxide/deposit layer with variable composition and relatively low levels of sulphur and chlorine.

At the lower test temperature of 320°C there was a thinner and more compact corrosion product layer on 304L, Figure 8. This had a variable composition but no clear structure and again only low levels of chlorine, below 5%.

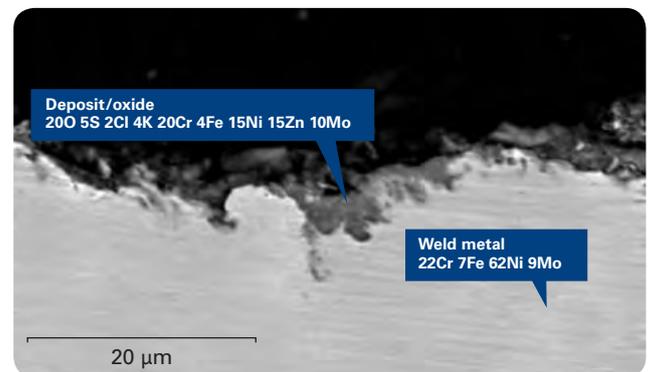
Fig. 9 Small areas of deposit/oxide present on weld overlay exposed at 420°C for 12 cycles.

For the nickel-base overlay weld, the amount of corrosion was very limited. At 320°C corrosion gave only a slight surface discoloration on which the original grinding marks were still visible. At 420°C the metal loss was measured as 17 µm, Figure 3, and this is also seen from the surface roughness in Figure 9. Only very small pockets of oxide, containing some sulphide and chloride, were retained on the surface. Sulphidation of the deposit by reaction with the gas atmosphere, which was very clear for the carbon steel, also occurred for the nickel-base overlay weld. However, there was no indication of nickel sulphide formation. This generally becomes more of a problem at higher temperatures, where the nickel-nickel sulphide eutectic melting at 635°C can form.

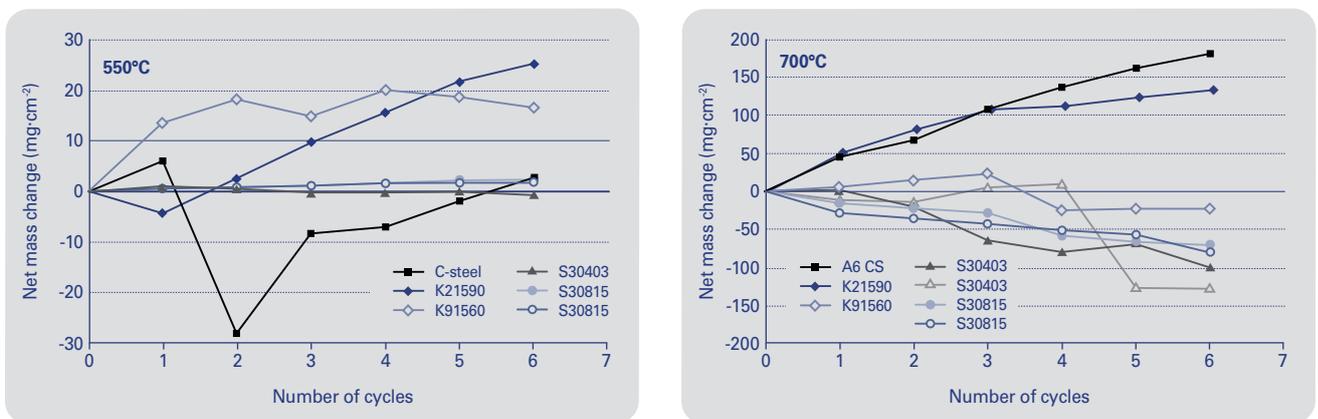
Fig. 1 Net mass change curves at 550°C and 700°C in simulated biomass combustion environment with a KCl-K₂SO₄ deposit which was renewed every 160 hour cycle.

The net mass change curves at the two temperatures are shown in Figure 1. At the lower temperature of 550°C the carbon steel showed uneven mass change, which indicated that erratic spalling had occurred. The total amount of spall at the end of the test, Figure 2, was also highest for this material. At the higher temperature of 700°C the gross mass change of the carbon steel was higher by a factor of approximately 4, but the amount of spallation was less than at 550°C. The 2Cr steel (K21590) showed mass changes in parity with those of carbon steel, but less spallation at 550°C. The most unusual behaviour was shown by the 9Cr steel (K91560) which had similar levels of mass gains at the two test temperatures. The stainless steels S30403 and S30815 showed good reproducibility between duplicate specimens. At 550°C they showed low net and gross mass gains, with little spallation. The mass gains were not much higher than the total amount of deposited salt, which was a total of 4.8 mg·cm⁻² over the duration of the test. At 700°C the stainless steel gross mass gains were in the range 20–80 mg·cm⁻², with the lowest values being measured for S30815. The amount of spalled oxide was actually higher for the stainless steels than for the low alloyed steels; the consequence of this was that there was a net mass loss seen for all the stainless steels.

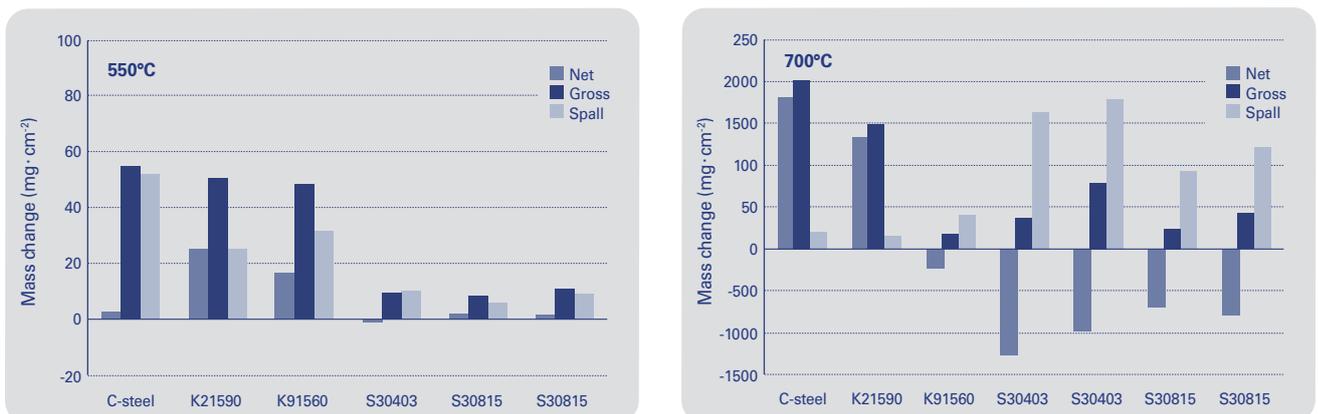
Fig. 2 Total net and gross mass changes and total amount of spall at the conclusion of testing in simulated biomass combustion environment with a total exposure time of 960 hours.

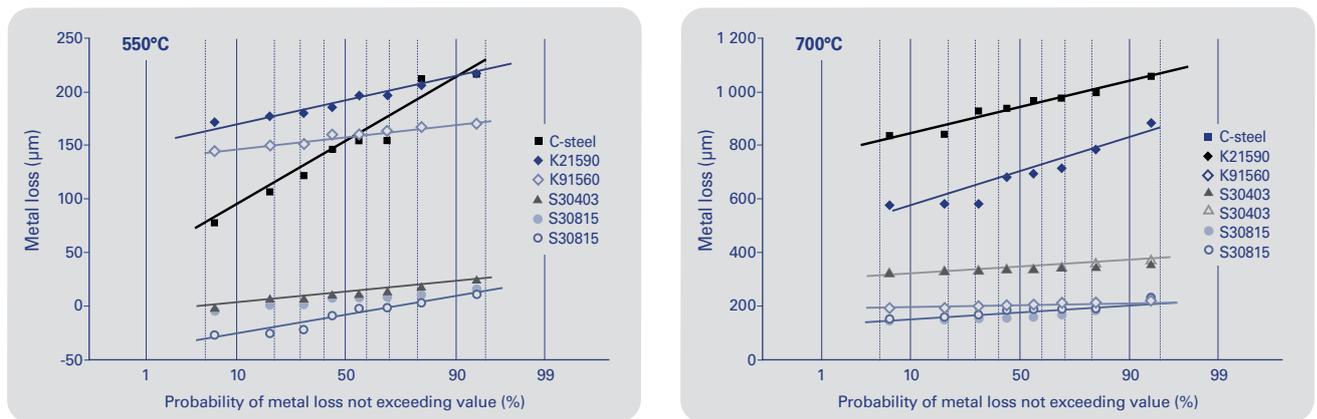
Fig. 3 Probability plots of metal loss obtained from post-test metallography

The results of measurements on cross sections are shown in Figure 3 and Figure 4. The metal loss followed a normal distribution, with higher standard deviations (reflected in the slope of the probability curves) for the lower alloyed materials. At 550°C the alloys fell very clearly into two groups. The carbon steel and low alloyed steels K21590 and K91560 showed high metal losses of over 150 µm, which extrapolates to around 2 mm·year⁻¹ if linear kinetics are assumed. The two stainless steels S30403 and S30815 exhibited very low losses. In some cases even negative values were recorded. This is because slight inaccuracies are inevitable when comparing pre-test micrometer measurements with post-test measurements in a travelling stage microscope, particularly when metal loss is so low.

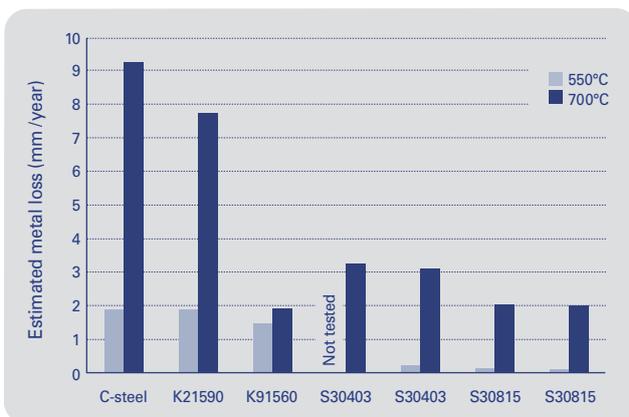
**Fig. 4** Estimated annual metal loss based on an assumption of linear kinetics.

At 700°C the extrapolated annual metal loss was 8–9 mm for the two lowest alloyed steels, i.e. approximately a factor 4 higher than at 550°C. Corresponding values for the stainless steels were 3 mm·year⁻¹ for S30403 and 2 mm·year⁻¹ for S30815. Both of the stainless steel grades showed excellent agreement between duplicate specimens. The only anomaly in the pattern was for the 9Cr steel K91560. This showed metal loss at 700°C which was only slightly higher than that at 550°C, Figure 5. This correlates to the observations from the mass change measurements, but is rather difficult to explain. One possibility is that it

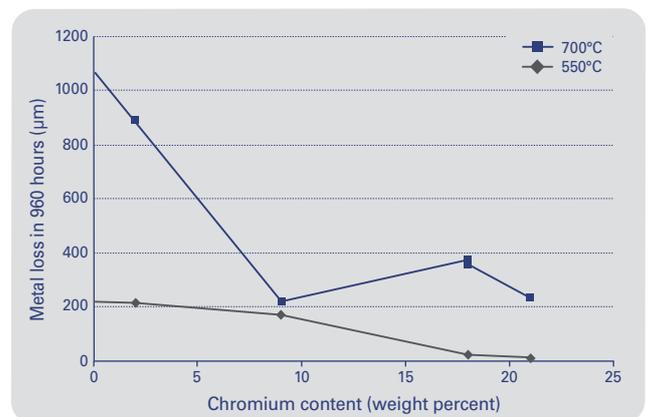
**Fig. 5** Maximum metal loss after testing for 960 hours in the simulated biomass combustion environment, as a function of alloy chromium content. The anomalous behaviour of the 9% Cr steel at 700°C may be due to the variable incubation time reported for this material.

may be related to the very large spread in incubation times for high temperature corrosion attack which have been reported for this alloy [11], and which mean that there is a shift between low and high corrosion rates. Longer term testing and/or a number of replicate specimens are clearly needed before firm conclusions can be drawn about this material.

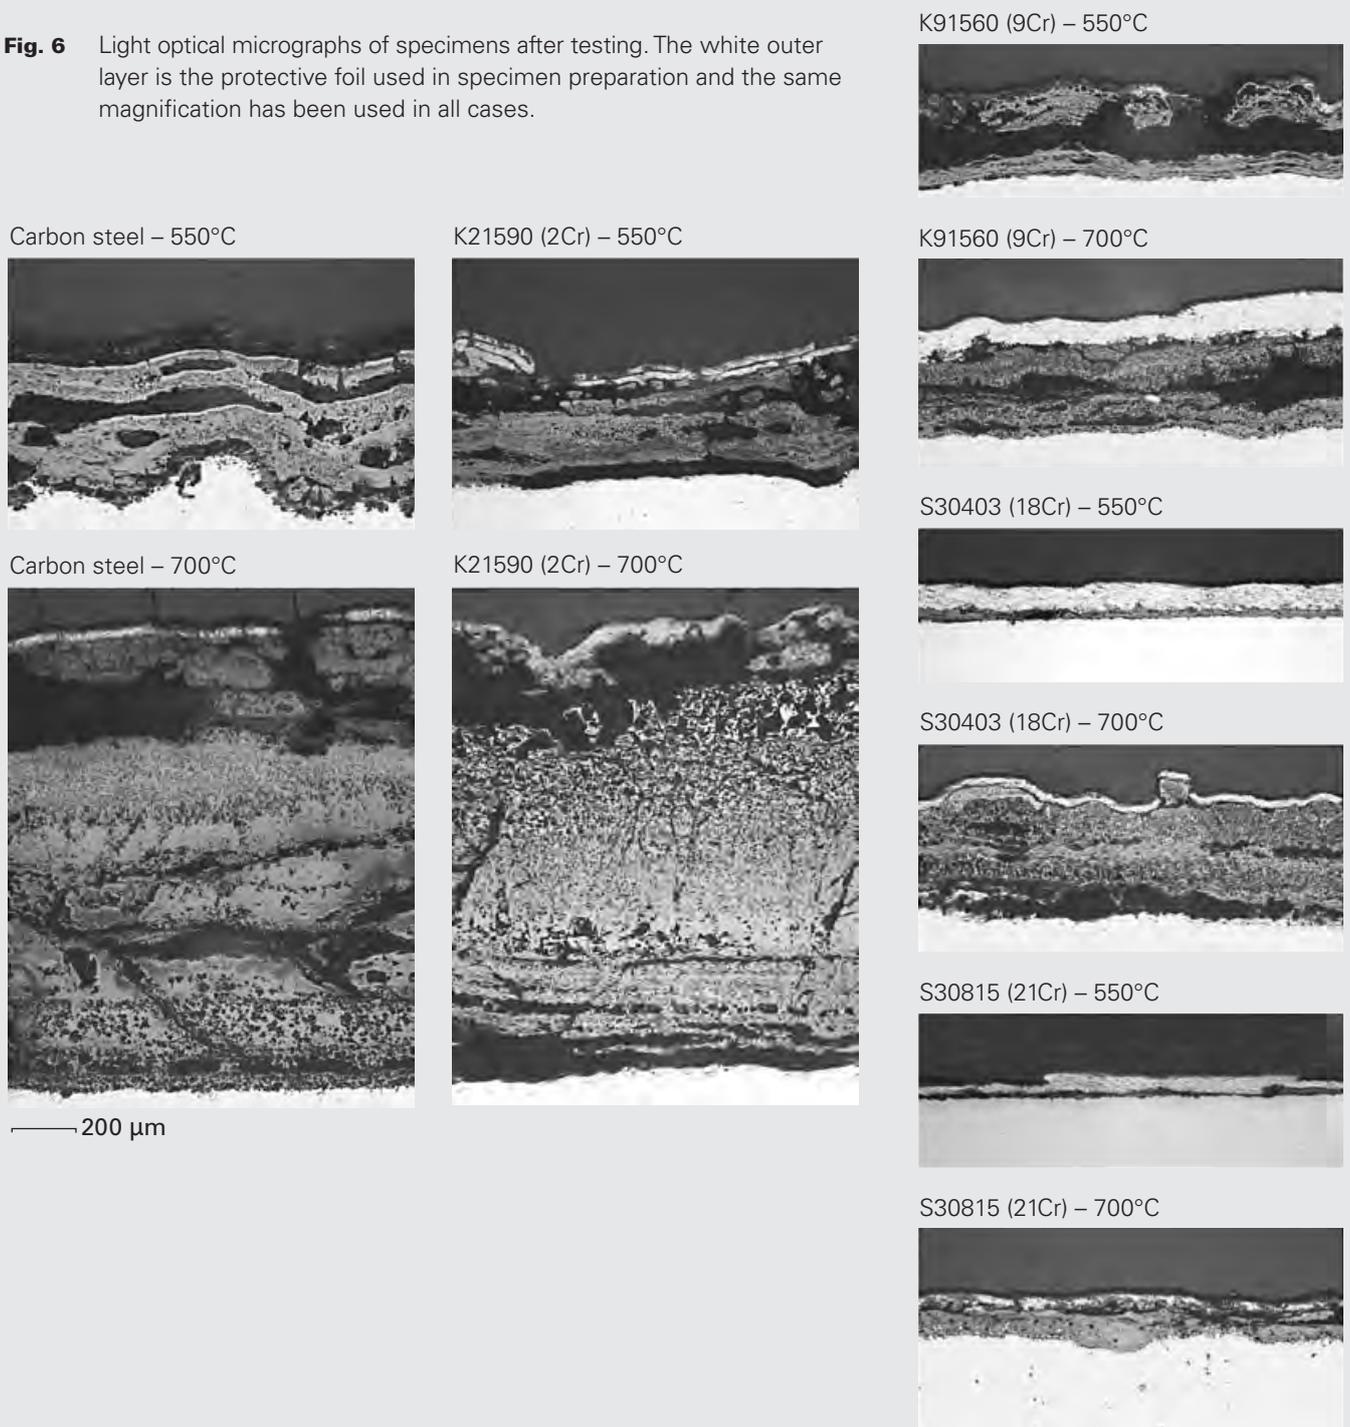
Fig. 6 Light optical micrographs of specimens after testing. The white outer layer is the protective foil used in specimen preparation and the same magnification has been used in all cases.

Figure 6 shows a comparison between light optical micrographs of the corrosion products on the specimens, all at the same magnification. The surface oxide was relatively uniform, with the exception of the undulating metal-oxide interface for carbon steel at 550°C.

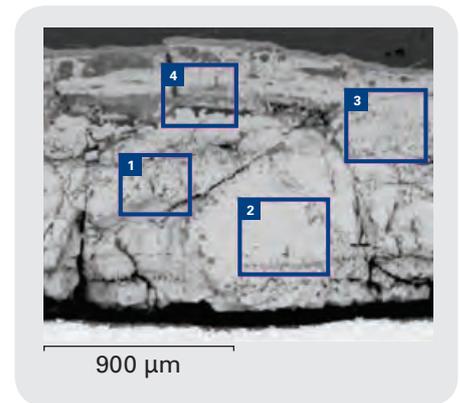
Fig. 7 Backscattered electron image of corrosion products on carbon steel after testing at 700°C. All marked points are iron oxides with only traces of Cl (<0.1%) and K (<0.5%)

for the carbon steel at 700°C in Figure 7. This is in notable contrast to the behaviour in a simulated waste combustion environment previously reported [12], where a continuous layer of iron chlorides was seen at the carbon steel-oxide interface.

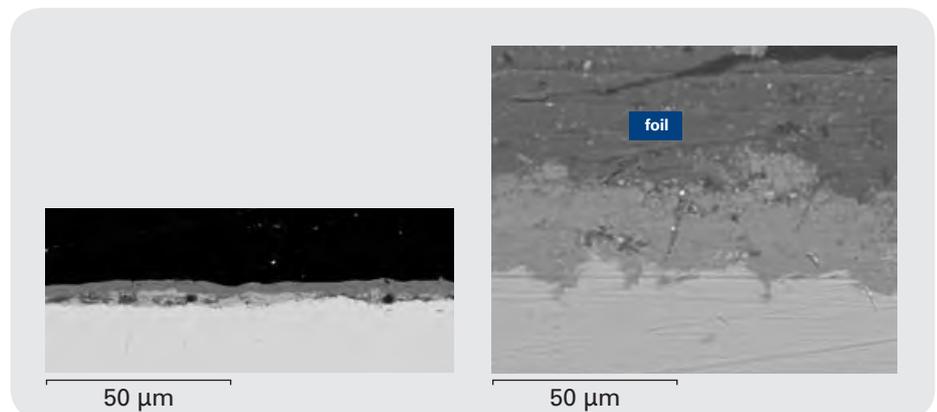
Fig. 8 S30403 after exposure in the low temperature biomass environment. The oxide layer is thin with no internal oxidation. The oxide consists mainly of iron (40–80 weight percent) and chromium (10–50%). Chloride was detected at low levels (0–2%) throughout the oxide and there were weak potassium signals (0–1%) but no significant amount of sulphur.

The stainless steels at 550°C showed a similar predominance of oxidation, with very little trace of K, S or Cl. Figure 8 shows that a single layer oxide around ~30 μm in thickness and containing 40–80% Fe and 10–50% Cr formed on S30403 (all analysis values are given in weight percent unless stated otherwise). Up to 2% Cl and 1% K could be detected within the oxide, but not as a clear separate phase, and there was no significant amount of sulphur. At the higher temperature of 700°C it may be recalled from the previous section that the majority of the oxide had spalled from the stainless steels. However, the micrographs in Figure 9 are taken at one of the places where the oxide scale was still attached to S30403, and show that in this case there was a thick, multi-layered oxide scale. The outer component was an iron-rich oxide containing up to 80% Fe, while the inner Cr-rich layer contained up to 75% Cr. There were low levels of potassium, <1% present in the Cr-oxide layer. Beneath the oxide scale there was a region of internal oxidation, where small oxide islands were surrounded by unoxidised metal. In this region it was possible to find small areas with high chloride contents, typically around 15% Cl, which provide strong indication that the chlorination mechanism described in the introduction is operative. The total thickness of the outer scale + inner oxidised region was ~300 μm. For comparison, the oxide formed on the same grade when exposed to synthetic air for 1000 hours at 700°C averaged only 6 μm [13]. The accelerating effect of the environmental contaminants applied in this work is thus very substantial.

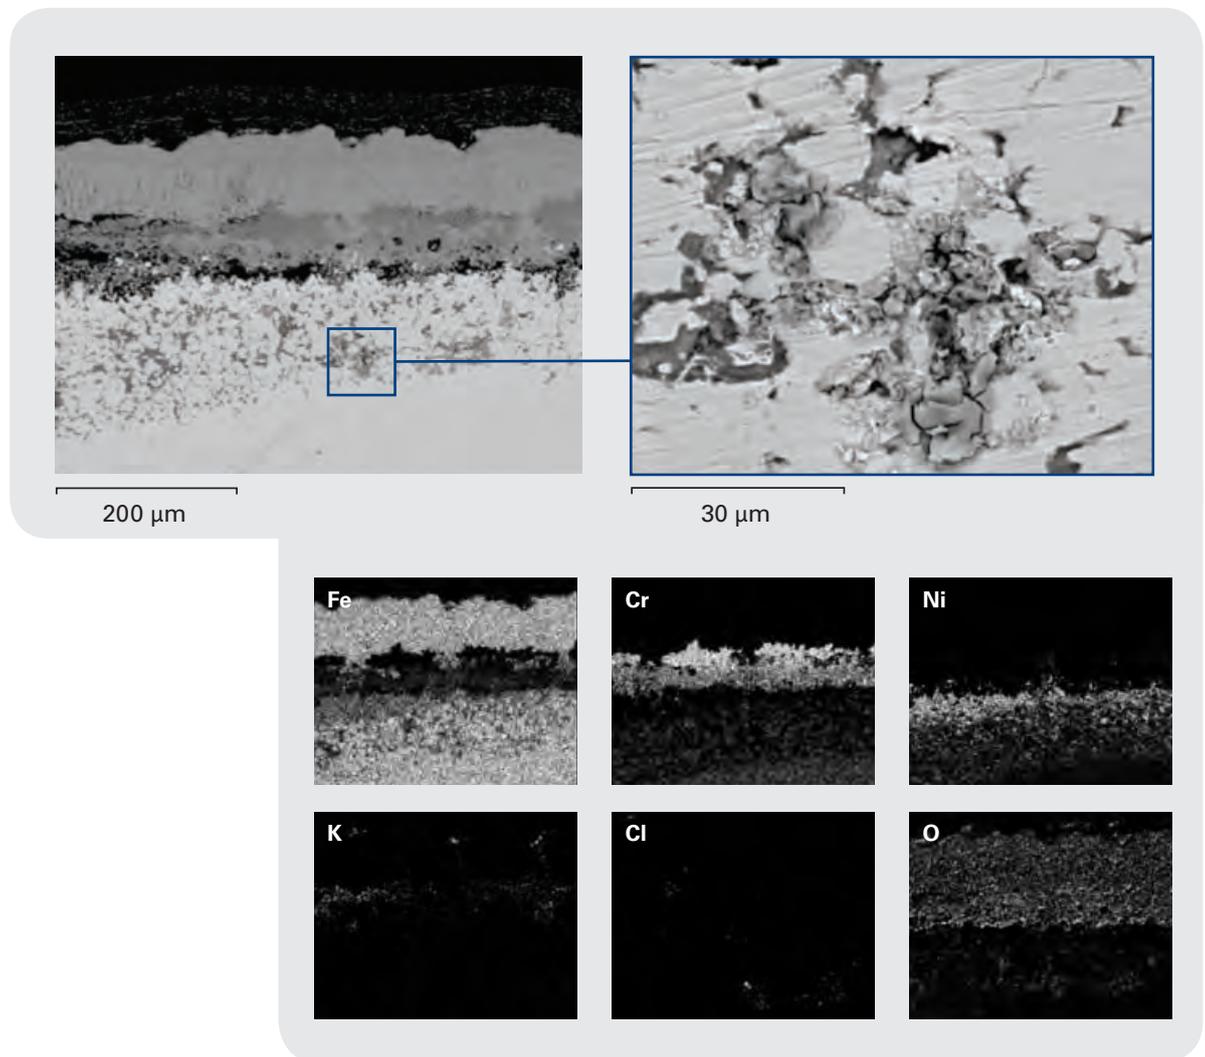
Fig. 9 S30403 after exposure in the high temperature biomass environment. There is a thick outer oxide of 100–200µm comprising an outer layer of iron oxide and an inner chromium-rich oxide. Chlorides were present in the internally oxidised region and particles such as those arrowed in the enlarged area had typical compositions of 20% O, 15% Cl, 5% Cr, 40% Fe and 10% Ni.

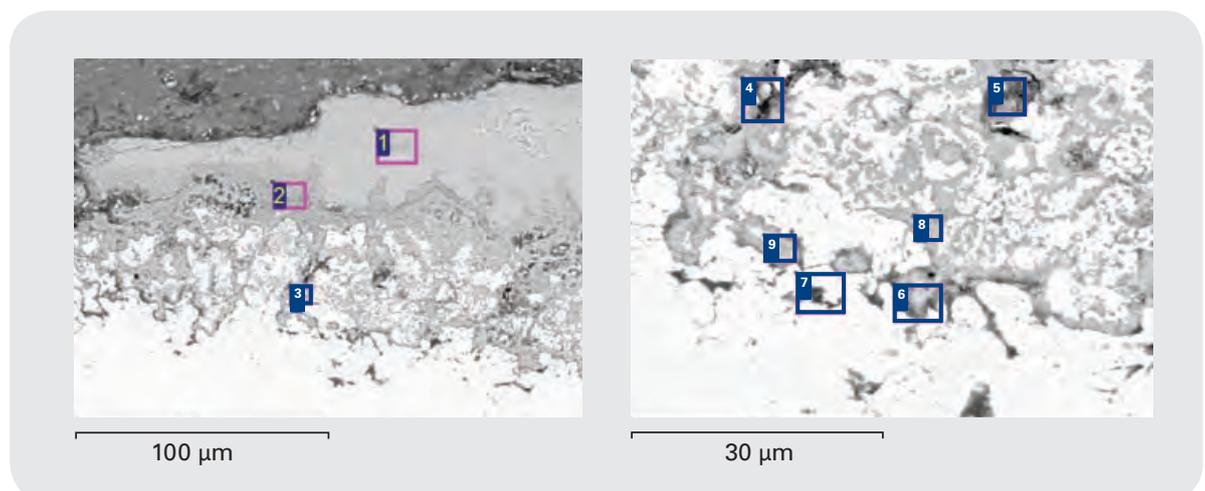
Fig. 10 S30815 after testing at 700°C. The outer oxide (1) contains ~60% Fe and 10% Cr while the inner oxide (2) comprises ~50% Cr and 20% Fe. All interface areas (4) to (9) are chromium-dominated oxide with up to 10% Si but less than 0.3% Cl and no measurable amounts of potassium.

picture in that there was an outer iron-rich oxide scale and an inner Cr-rich scale, also a region under the scale in which partial internal oxidation had occurred. However, the notable difference compared to S30403 was the lower amount of chlorine and the presence of silicon oxides within this internally oxidised region for S30815. The area analyses yielded up to 10% silicon, locally the amounts are therefore appreciably higher and it is reasonable to assume that a silicon oxide phase is present. This material is intentionally alloyed with ~1.5% silicon to improve the high temperature oxidation and corrosion resistance, and it seems that this has had a beneficial effect in the present case by blocking the sites at which chlorides would otherwise form.

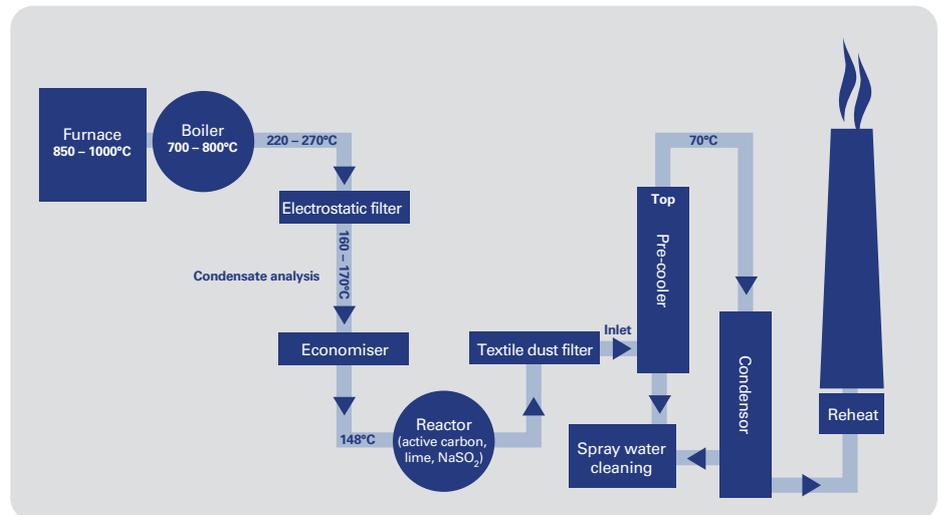
Fig. 1 Schematic illustration of the waste-fired district heating boiler used for condensate analysis and field testing at the inlet and top of the pre-cooler.

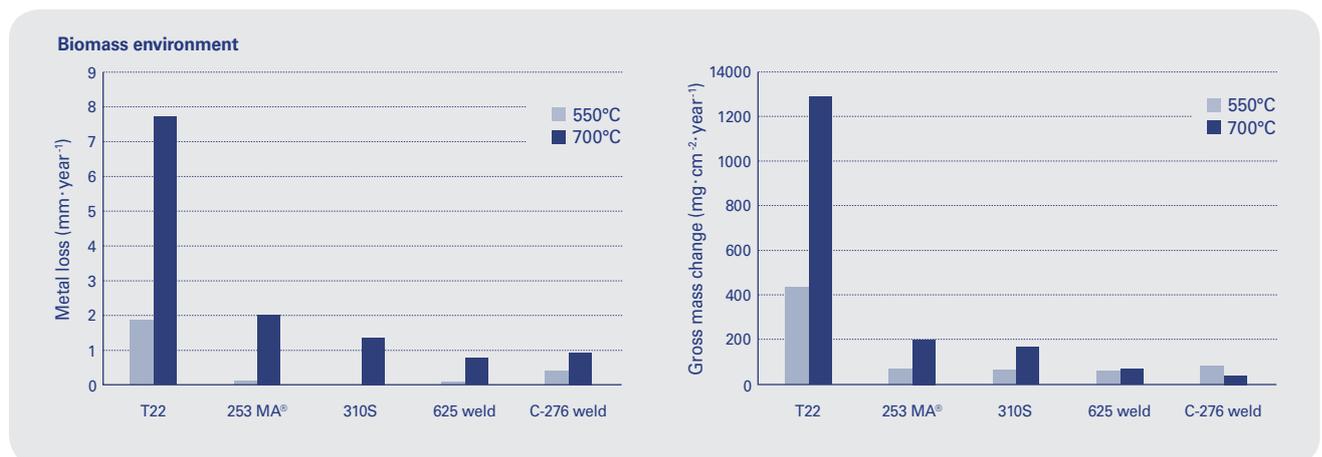
Fig. 2 Maximum metal loss in simulated biomass environments and measured gross mass change.

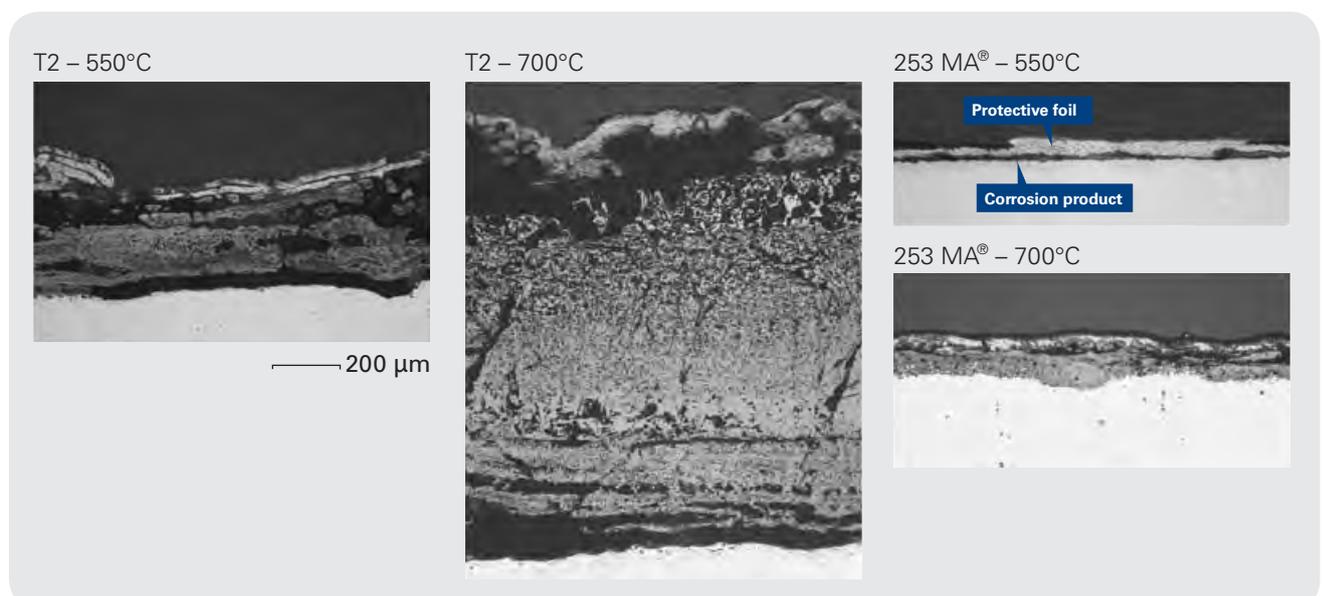
Fig. 3 Light optical micrographs showing corrosion products on T22 and 253 MA after testing in the simulated biomass combustion environments for a total hot dwell time of 960 hours.

The nickel-base alloys do not seem to show a performance which could merit the appreciably higher alloy cost involved. Increasing the temperature to 700°C, which is much higher than the current operating range for biomass boilers, naturally increased the corrosion rates for all materials. The corrosion rate of over 7 mm·year⁻¹ renders T22 highly unsuitable, while the corrosion rates were 1–2 mm·year⁻¹ for the stainless steels and ~1 mm·year⁻¹ for the nickel-base alloys. Examples of the corrosion attack are seen in the micrographs in Figure 3.

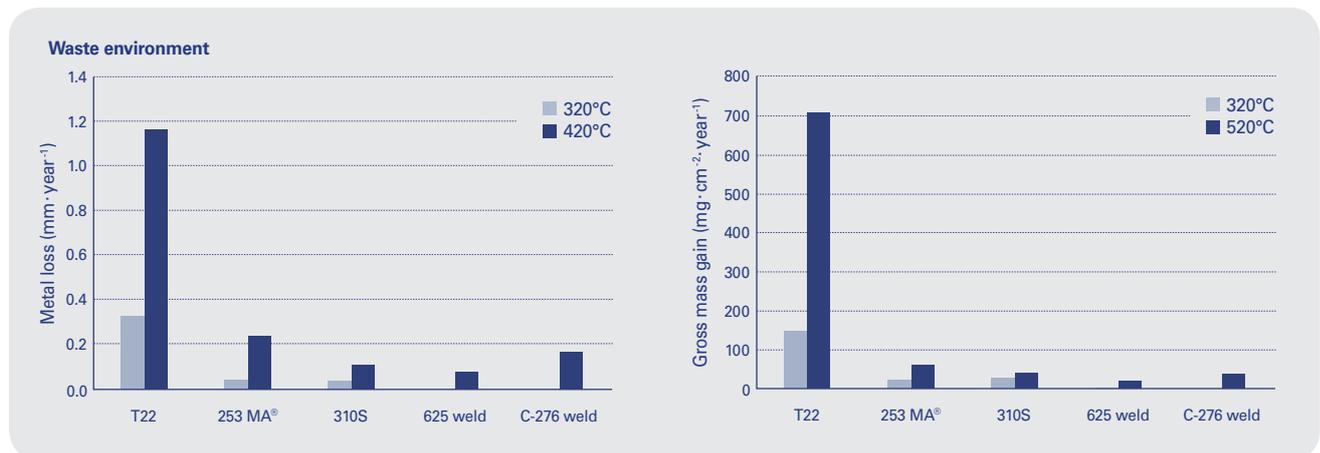
Fig. 4 Maximum metal loss in simulated waste superheater environments and measured gross mass change.

Corresponding metal loss and mass change data for the simulated waste combustion environments are shown in Figure 4. The first point to note is that the metal losses are appreciably lower than in the simulated biomass environments, by around an order of magnitude. The mitigating effect of the lower temperatures clearly outweighs the detrimental effect of the more damaging chloride salt deposit. Ranking of the materials shows similar trends to the biomass environment, with the highest metal losses unsurprisingly been shown by the low alloyed T22. At the lower temperature of 320°C the nickel-base alloys show barely measurable metal loss, but even that for the two stainless steels 253 MA[®] and 310S it is less than 50 µm·year⁻¹. Raising the temperature to 420°C increases metal loss for both austenitic stainless steels and nickel base alloys to ~100–200 µm·year⁻¹, so the utilisation of the former becomes comparatively advantageous.

The metal loss data indicates that if the low-alloyed T22 is replaced by 253 MA[®] or 310S stainless steel, the temperature in a waste-fired boiler could be increased from 320°C to 420°C and the corrosion rate nevertheless decreased. Caution must naturally be exercised in applying this data to the more complex situation in a waste combustion plant, but the results do indicate the potential gains from the use of more advanced materials.

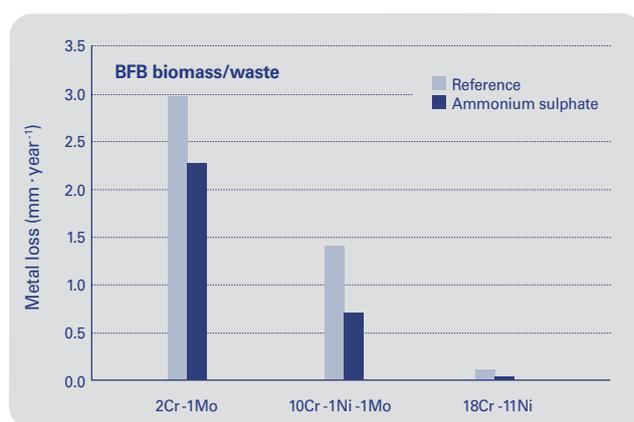
Fig. 5 Field testing data from cooled superheater probes in a BFB boiler fired with biomass and waste [6, 7].

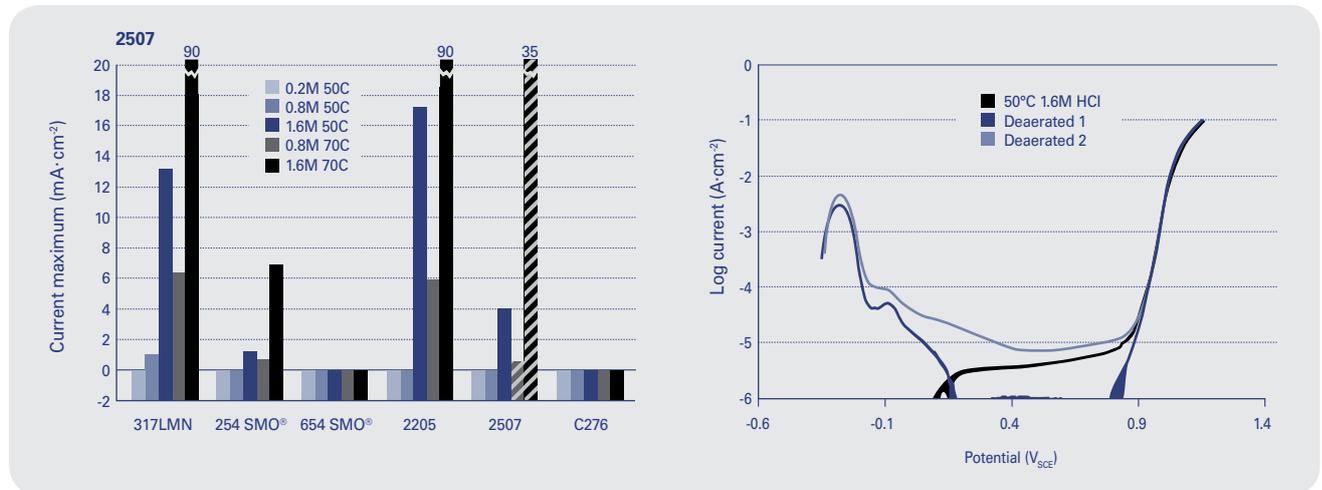
Fig. 6 Maximum current in polarisation curves in hydrochloric acid at different concentrations and temperatures. Shaded curves for 2507 indicate results when activation is used at the start of the potential scan. Without activation, or in deaerated conditions, the material is passive, as shown in the polarisation curves.

0.8M HCl and 1.6M HCl at 70°C which are shown by the shaded bars in Figure 6. Pitting corrosion was observed for 317 LMN in all five HCl environments, while the duplex steel 2205 exhibited pitting in 0.8M HCl and 1.6M HCl 70°C, and also showed some repassivating pitting at 50°C. This is in partial agreement with the alloy performance predicted from the empirical PRE relationship between pitting resistance and alloy composition, included in Table 3.

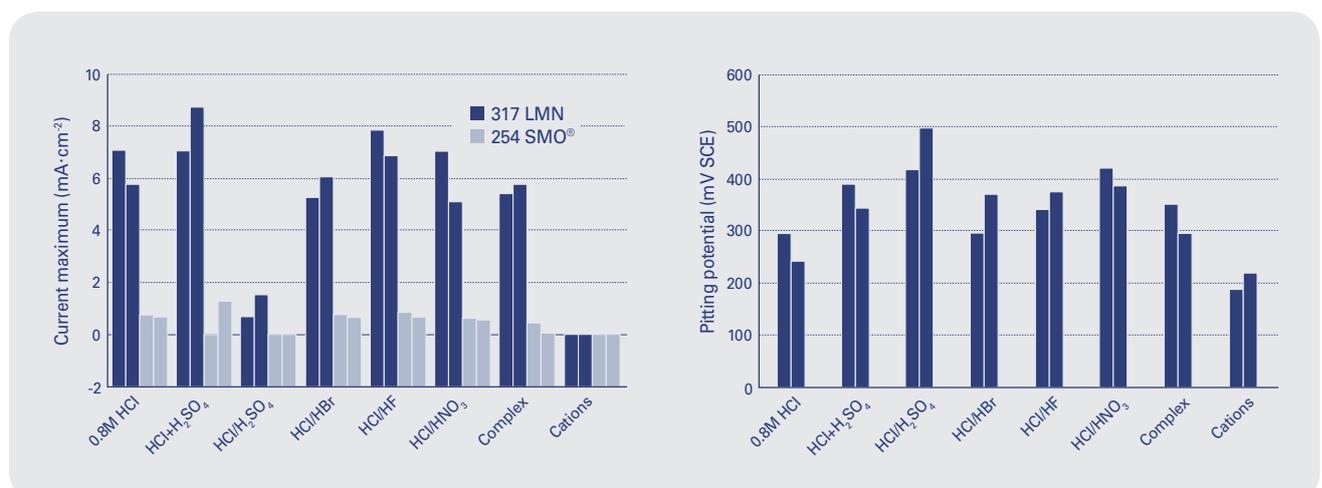
Fig. 7 Effect of additional species on the maximum current density in a base environment of 0.8M HCl at 70°C and on the pitting potential for 317 LMN. Environment designations according to Table 4.

The effect of the presence of other ionic species is shown in Figure 7 for duplicate specimens of 317 LMN and 254 SMO[®]. Partial replacement of HCl by H₂SO₄ had a beneficial effect, causing 254 SMO[®] to passivate (as seen by the higher corrosion potential), decreasing the maximum current density for 317 LMN and also raising the pitting potential. Addition of sulphuric acid to the 0.8M HCl base solution induced passivation for one of the two specimens of 254 SMO[®] and increased the pitting potential for 317 LMN again indicating an inhibitive effect of sulphate. However, it also gave a minor increase in the corrosion rate of 317 LMN. The effect of sulphur is an interesting one in view of the high temperature sulphur effect discussed in §4.2. It means that sulphur additions made to mitigate high temperature chloride-induced corrosion can also have a beneficial downstream effect under acid condensation conditions. The disadvantages are

Partial substitution of chloride by bromide, nitrate or fluoride had only a marginal influence on uniform corrosion, but nitrate increased the pitting potential for 317 LMN. Cation addition had a beneficial effect, causing both materials to shift to from active to passive behaviour because of the increase in redox potential, but also decreased the pitting potential for 317 LMN.

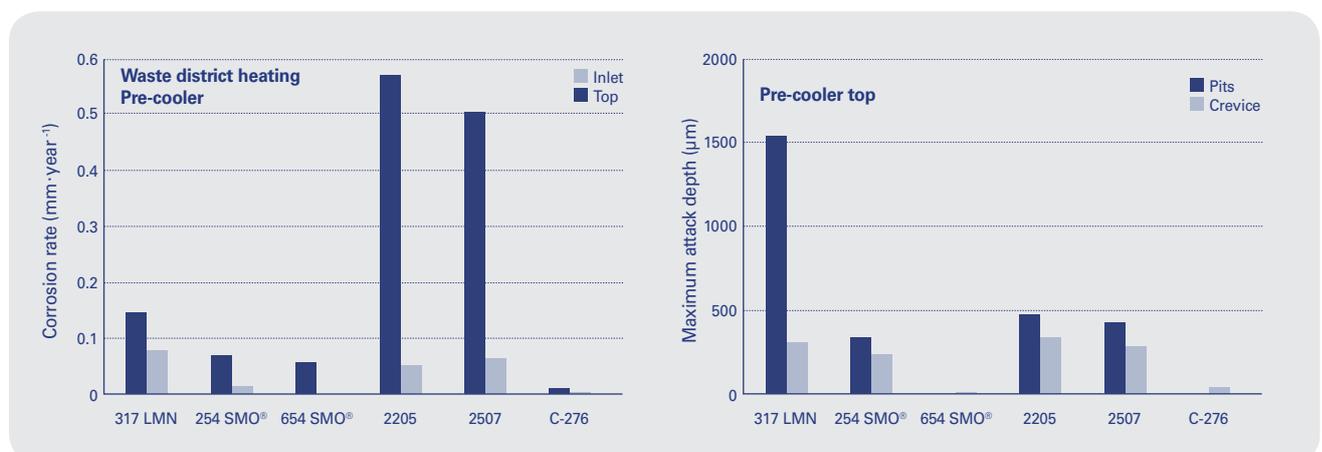
Fig. 8 Corrosion rates evaluated from test coupons exposed for 7 months in the pre-cooled of a waste-fired district heating plant, also maximum attack depths measured for specimens at the top of the pre-cooler.

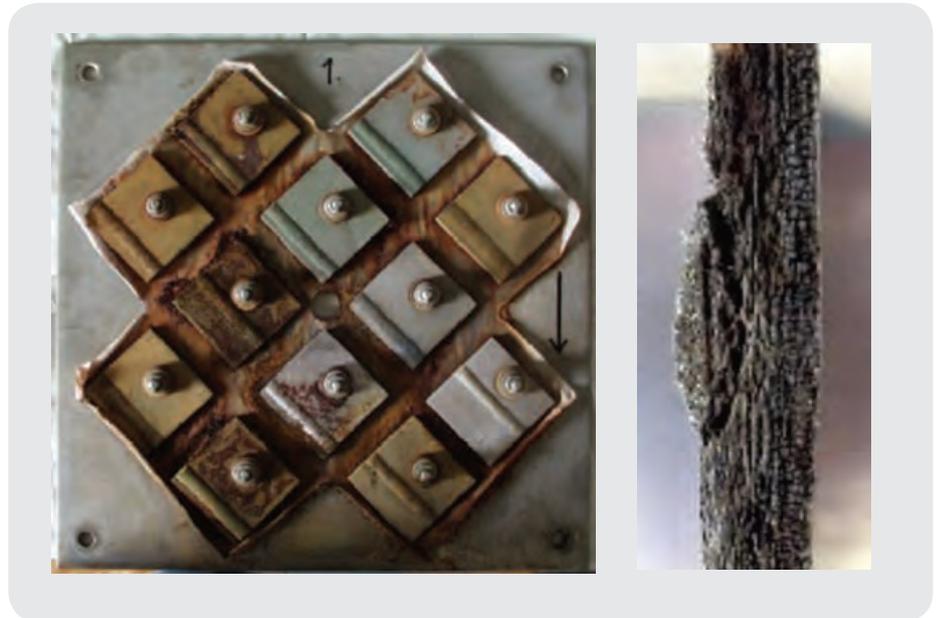
Fig. 9 Appearance of test panel after exposure for 7 months at the pre-cooler inlet and section of 2507 specimen showing corrosion in the fusion line.
