Stainless steels for flue gas cleaning

– laboratory trials, field tests and service experience

B. Beckers, A. Bergquist, C.-O. A. Olsson, M. Snis, and E. Torsner
Outokumpu Stainless AB, Avesta Research Centre
SE-774 22 Avesta, Sweden

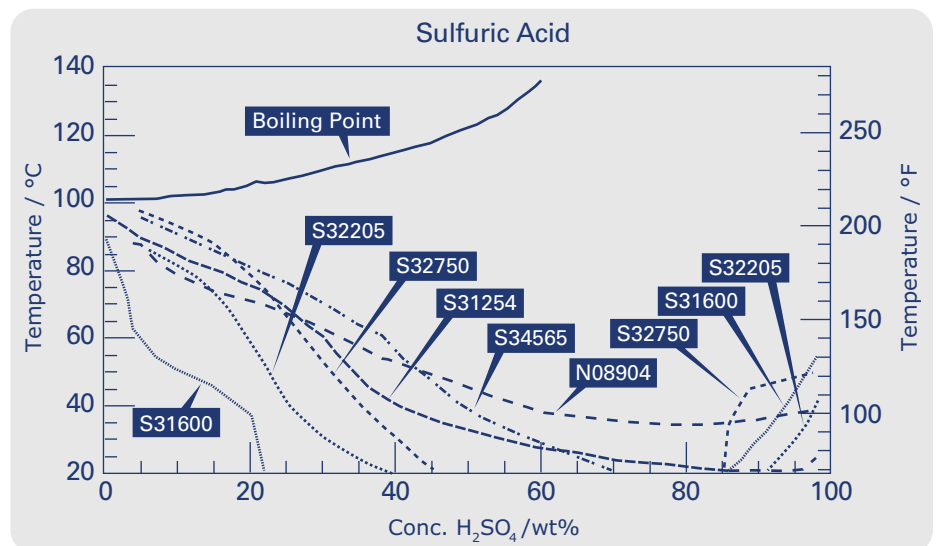
Fig. 1 Isocorrosion diagram (0.1 mm/y) in pure sulfuric acid.

Generally, the uniform corrosion resistance of a stainless steel is enhanced with increasing contents of chromium, nickel and molybdenum. The corrosion rate is often given in mm/year and can be presented in isocorrosion diagrams showing the combination of acid concentration and temperature giving a corrosion rate of 0.1 mm/y (3.9 mpy). Isocorrosion diagrams can be used for comparing the corrosion resistance between grades in different media but also as tools for material selection. Figures 1 and 2 show isocorro-

sion diagrams in pure sulfuric acid, and in sulfuric acid with addition of chlorides[3]. It should be noted that the presence of chlorides markedly increases the corrosion rates for all grades.

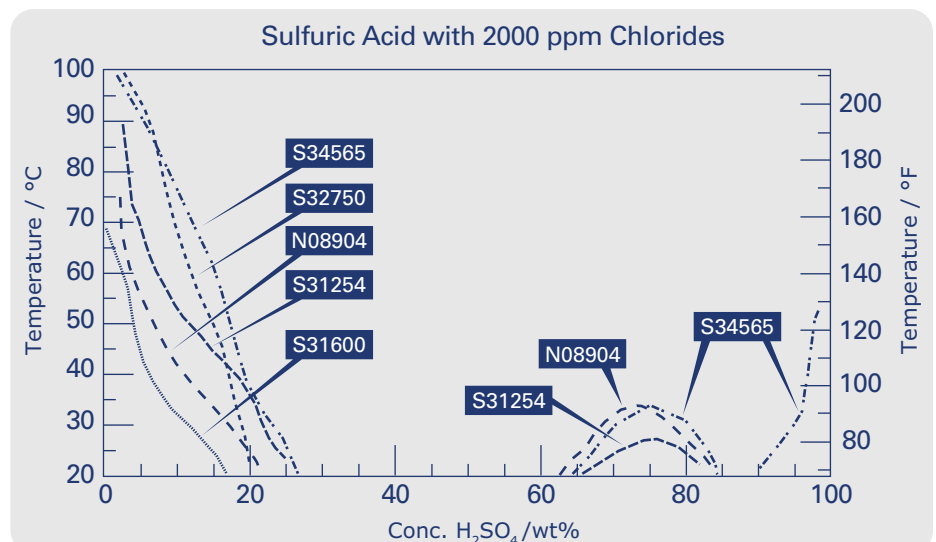
Fig. 2 Isocorrosion diagram (0.1 mm/y) in sulfuric acid with addition of 2 000 ppm chlorides.

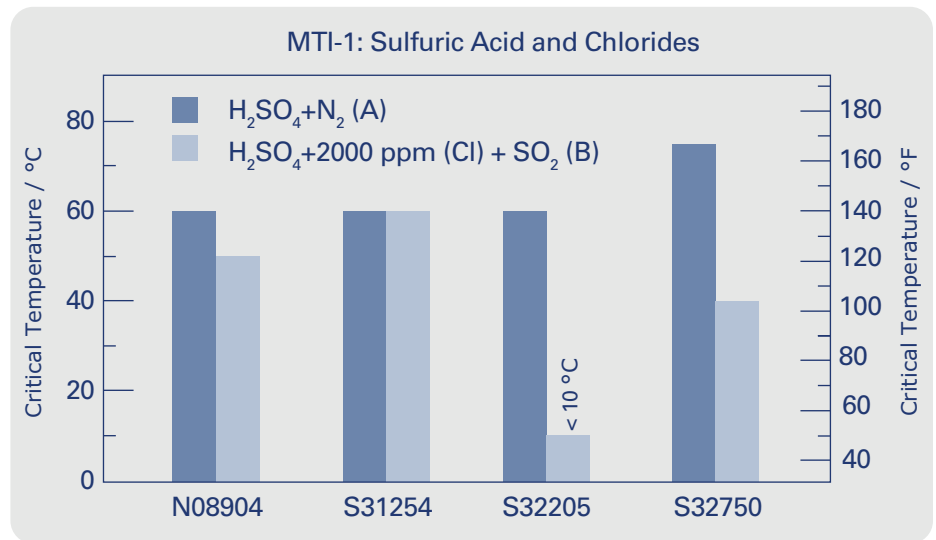
Fig. 3 Critical temperatures (MTI-1) in sulfuric acid solutions.

Figure 3 shows the critical temperature, i.e. the lowest temperature where the corrosion rate exceeds 0.127 mm/y (5 mpy) measured according to method MTI-1 [4] for different grades in two sulfuric acid solutions [5]. The data were taken from reference [5], with addition of new values for the grade S32750. In the pure dilute sulfuric acid (A) grades N08904, S31254 and S32205 have the same resistance whereas grade S32750 shows a higher resistance. In the simulated scrubber solution (B), the results are quite different despite the same sulfuric acid concentration. The presence of chlorides and sulfur dioxide does not influence the resistance of S31254 and only slightly N08904, whereas the corrosion resistance of the duplex grades S32205 and S32750 decreases dramatically.

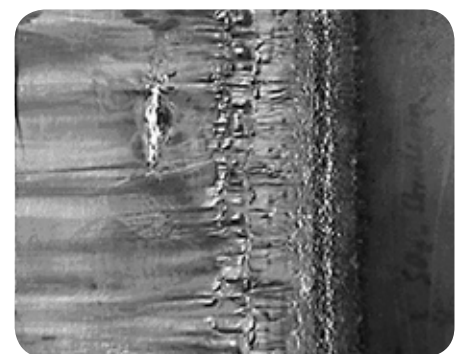
Fig. 4 A corroded 316-type pipe wall in a draft valve.

Figure 4 shows a part from a 316-type pipe wall in a leaky draft valve, where sulfur trioxide, containing gas on the right side leaked through the valve and condensed, forming sulfuric acid on the other side (left), resulting in severe corrosion. The unattacked pipe wall to the right had a thickness of 6 mm (0.24"), while the pipe wall was partly perforated to the left. The steel grade of the draft valve was changed to N08904.

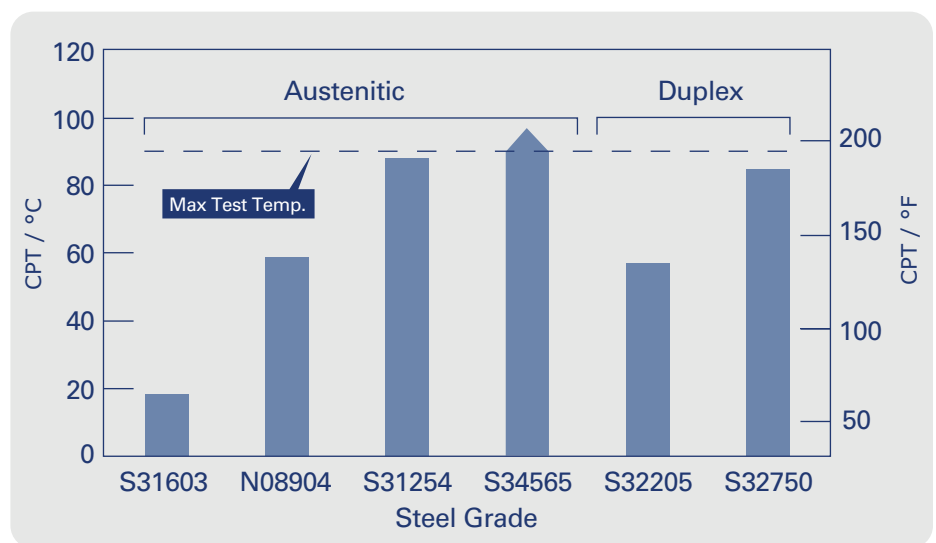
Fig. 5 Typical CPT values in 1M NaCl for some stainless steels tested in ground condition according to ASTM G150.

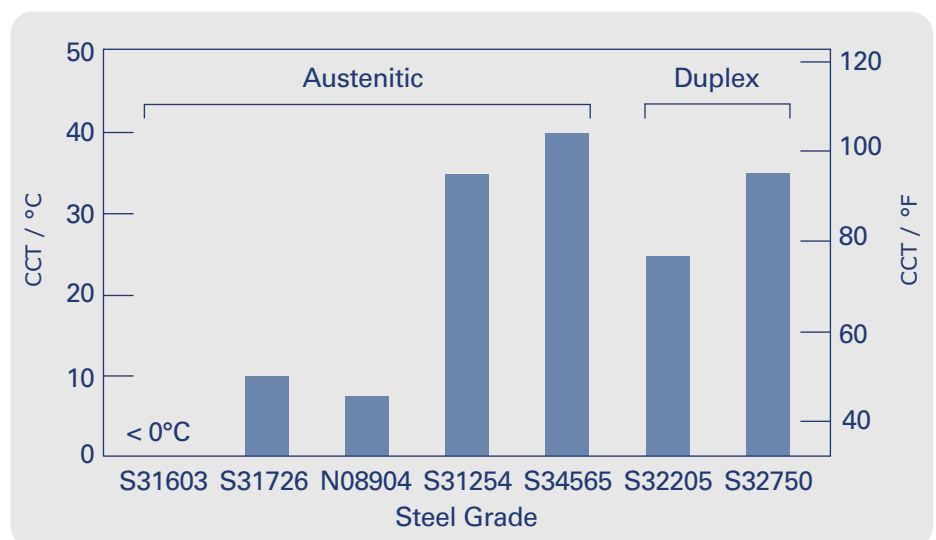
Fig. 6 Typical CCT values in 6% FeCl₃ + 1% HCl for some stainless steels tested in ground condition according to ASTM G48 Method F.

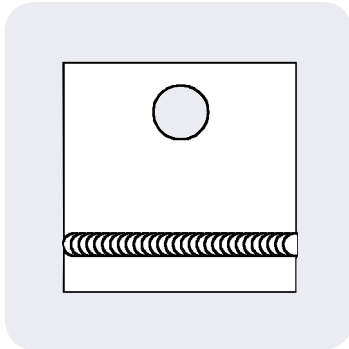
Fig. 7 Welded test specimen.

Specimens according to Figure 7, in size 60x60 mm, were mounted on test racks similar to the one shown in Figure 8. On both sides of each specimen, multiple crevice formers of PTFE were mounted. The test racks were then assembled with a torque of 1.58 Nm (14 lb-in). All specimens were insulated from each other and from the test rack.

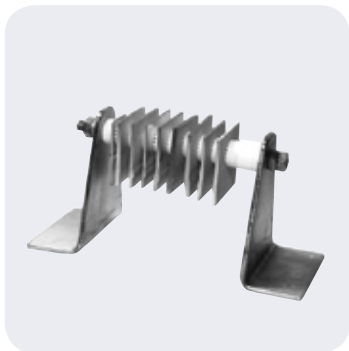
Fig. 8 Example of test rack.

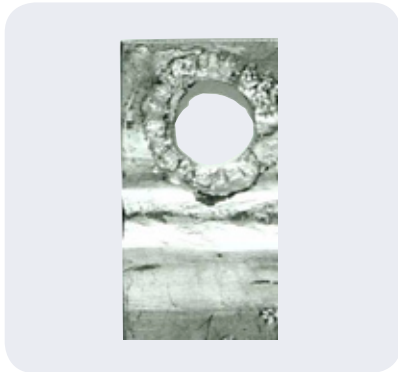
Fig. 11 Grade S31600

The conditions during this test were more severe, i.e. a higher chloride content, than in any of the tests in the artificial scrubber environments in Table 2 or in field test 3. Still, grades S31254 and S32750 performed rather well in the spray tower even if they suffered slight crevice corrosion. The reason for the relatively good performance was probably due to the higher pH in the field test. Grade S31600 suffered uniform corrosion with a corrosion rate of 0.163 mm/y (6.4 mpy).

Figures 11 to 16 show some of the specimens after testing in the spray tower.

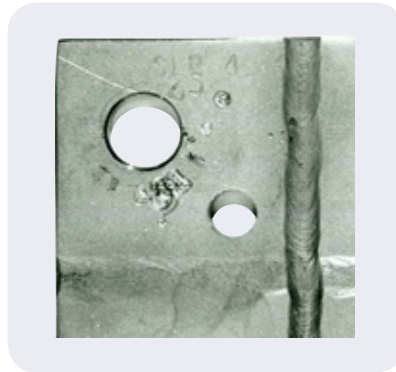
Fig. 12 Grade S31726

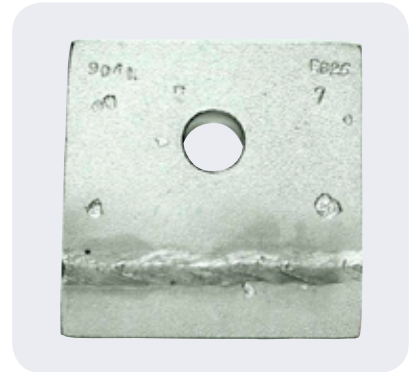
Fig. 13 Grade N08904

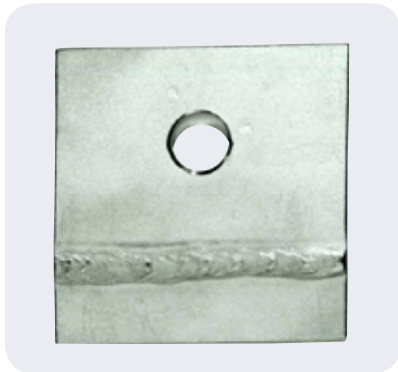
Fig. 14 Grade S31254

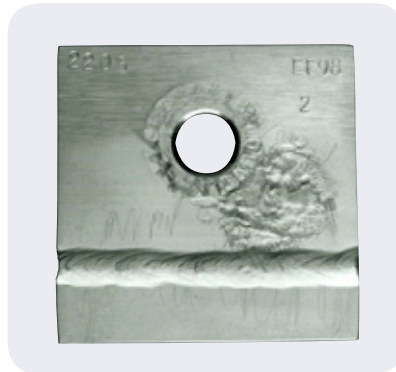
Fig. 15 Grade S32205

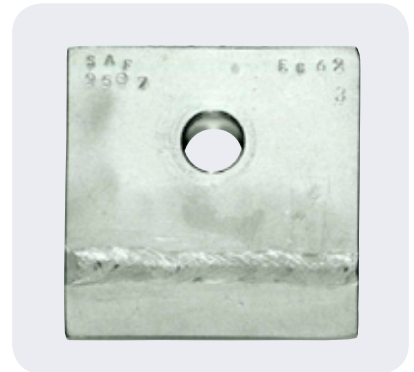
Fig. 16 Grade S32750

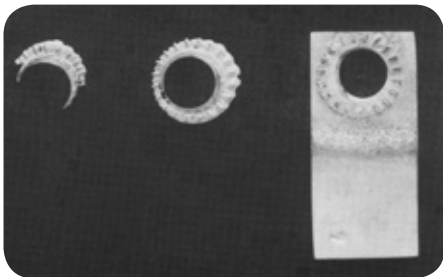
Fig. 17 Titanium specimens exposed in flue gas cleaning systems containing hydrogen fluoride.

In plants with a mixture of biomass and assorted waste there is a trend that the use of higher alloyed steels increases with an increasing part of such waste in the fuel. The condenser inlets may be made of S31254, GRP (Glass-Reinforced Plastics) in scrubber condensers) or by lining with PTFE (PolyTetraFluoroEthylene). The upper tube plate in tubular condensers may be made of S31254. The separate plate heat exchanger in scrubber condensers has, in some cases, been made of titanium in plants for waste incineration. The latter is presumably valid for fuels, which do not contain substantial amounts of fluorine. Otherwise the corrosion resistance of titanium should be strongly questioned. Figure 17 shows three titanium specimens exposed in two waste incineration plants containing hydrogen fluoride in the flue gas. These specimens were attacked by severe uniform corrosion, and only the parts shielded by the crevice formers remained of the two specimens to the left [7].

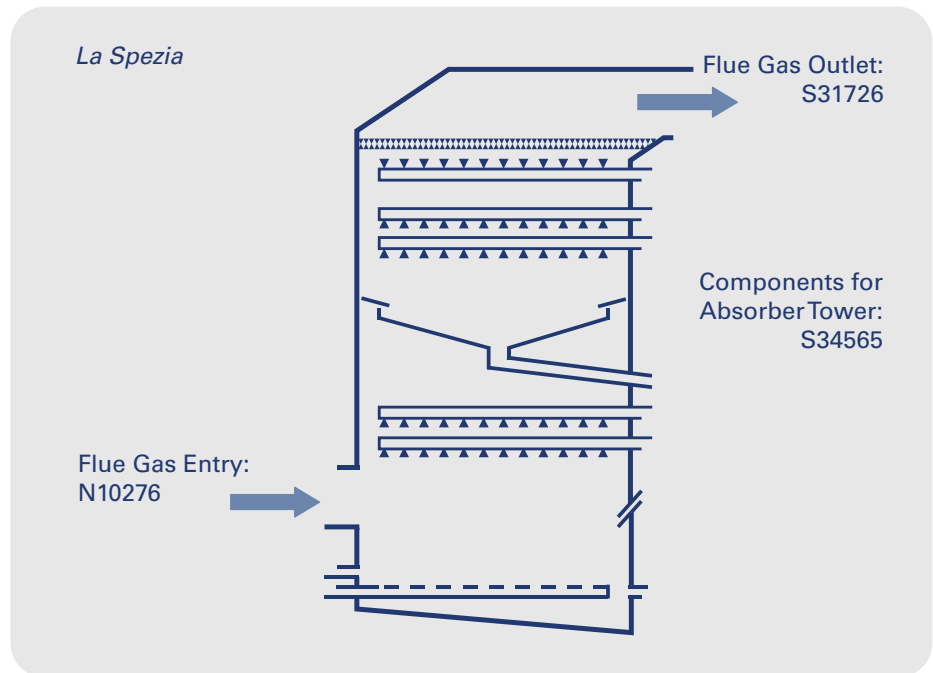
Fig. 19 Schematic of the double loop absorber installed in the la Spezia power plant of the Italian ENEL group.

Figure 19 shows a schematic sketch of the double loop absorber installed in the La Spezia power plant of the Italian ENEL group. Apart from the raw gas entry where nickel-base alloy N10276 has been applied, the whole absorber tower including internals like distributing pipes, spraying systems, sieves, collection bowl, demister support are made out of stainless steel grade S34565. Downstream the demister, i.e. for the wall plates of the gas outlet, S31726 was selected.

La Spezia has been the first power station where ENEL specified grade S34565 for the bulk portion in a FGD system. Meanwhile this plant is in operation for more than five years without any corrosion problems. ENEL honored this positive experience and specified grade S34565 in the meantime for several other FGD projects – installation of new FGD plants as well as replacement of different components like spraying systems and exhaust draft fans in existing power plants where originally selected material suffered from crevice corrosion attack.
