The Use of a Lean Duplex Stainless Steel, UNS S32101:

Thermal Dimple Jackets on Vessels for High Purity Applications.

Abstract

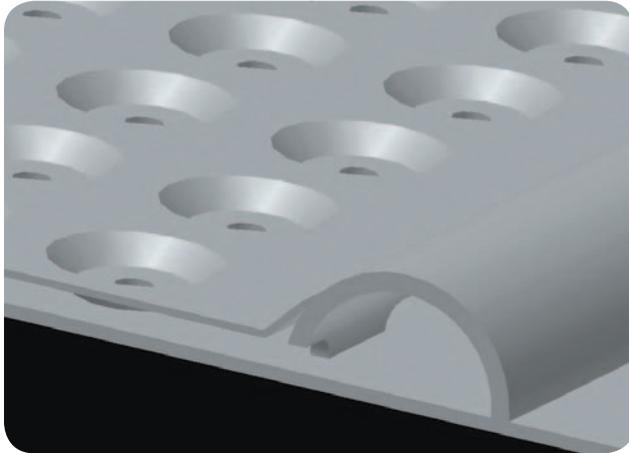
Fig. 1 3-dimensional cut-away drawing of thin-gauge dimple jacket on vessel sheet/plate with a 'Half-Pipe' Inlet/Outlet Header.

The basic design of embossed dimple jackets is covered in ASME Section VIII, Division 1, Appendix 17[1]. There are several methods for design and fabrication of these jackets. The method investigated in this study is the embossed dimple jacket welded to a plain (back-up) plate using a semi-automatic GMAW plug weld with filler metal (reference ASME Section VIII, Division 1, Appendix 17, 17-1(b)(3) figure 17-5)[1]. With this design, the dimple jacket is pre-formed from thin gauge sheet material and welded to the vessel shell or head using a GMAW plug weld utilizing filler wire. See Figures 1–3.

Most failures occur at the inlet and outlet 'headers' (see Figures 1, 3) because these are the areas that see the most drastic temperature changes and have higher stress concentrations, therefore special attention to these areas can increase the service life.

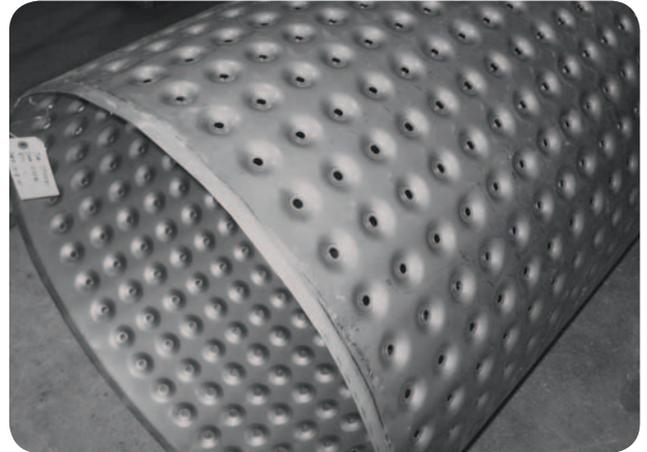
Fig. 2 Formed and rolled dimple jacket sheet prepared to install on vessel shell.

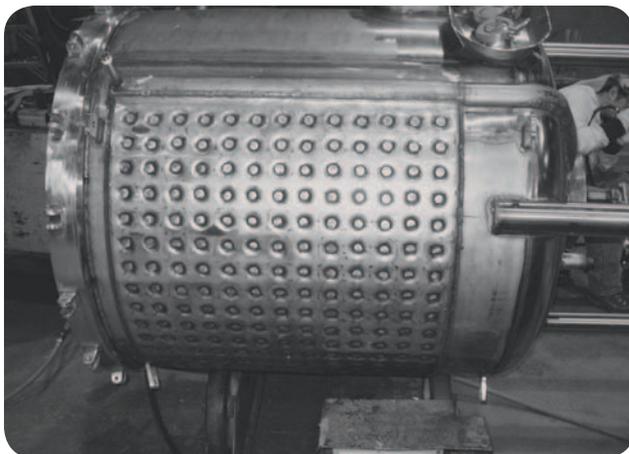
Fig. 3 Dimple jacket and 'Half-Pipe' headers welded on vessel.

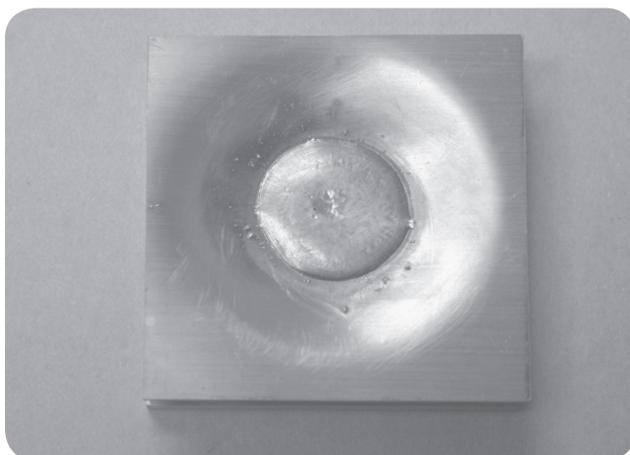
Fig. 4 Typical plug welded corrosion specimens used to evaluate the pitting resistance of the S32101 dimple jacket assemblies.

Data on the stress corrosion cracking, crevice, and pitting resistance (including PREN comparisons) for the three alloys are readily available in the literature and producers data sheets, however no corrosion testing of actual dimple jacket plug welded assemblies has been performed. Because of this, corrosion tests were performed on single plug-welded coupons (See Figure 4) using a 5% ferric chloride -1% sodium nitrate test solution. This solution was chosen so that the critical pitting temperatures of the 316L and S32101 stainless steels would be well above room temperature allowing the use of a standard temperature bath for the test exposures. Samples with different plug weld fillers and shielding gases were tested. Included in this testing is a sample made with a 316L dimple jacket welded to a 316L back-up plate. This sample was included to compare the corrosion performance of S32101 and 316L dimple jackets. Welded coupons were exposed to the test solution for 72 hours at a test temperature of 40°C and the weight loss and a description of the attack were recorded. These exposures resulted in attack primarily on the 316L back-up plate. Because of this the weight loss is reported as grams per area of the 316L back-up plate. The results of this testing are summarized in Table 3. Figures 5 (A) and 5 (B) show the typical attack found on the mill surfaces and edges of the 316L back-up plate and Figure 6 shows the typical attack found on the 316L dimple jacket and back-up plate edges.

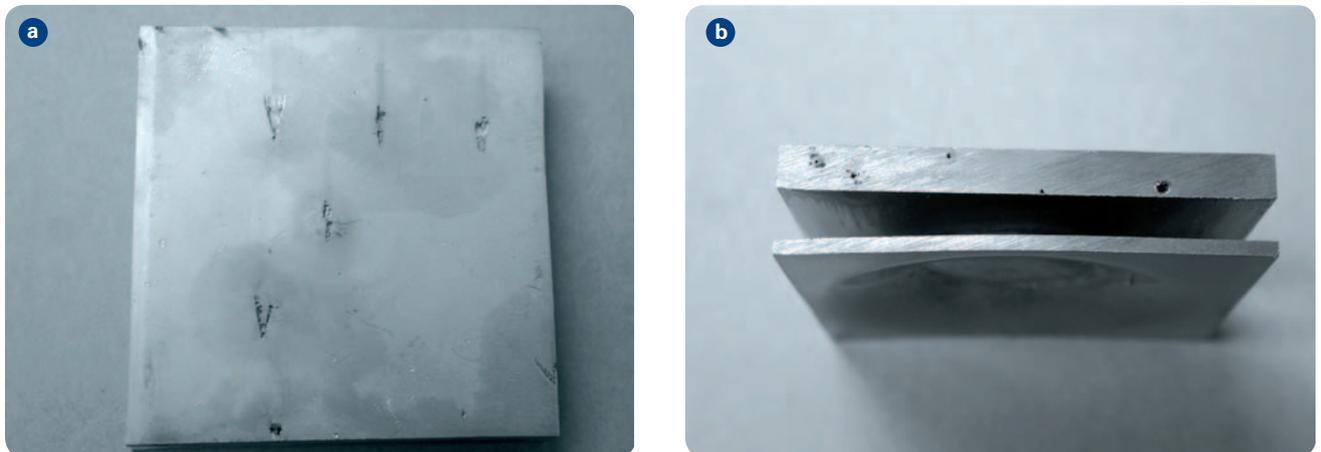
Fig. 5 Typical corrosive attack found on the 316L back-up plate. (A, left) shows pitting on the mill surface of the 316L Plate. (B, right) shows severe pitting on the edges of the 316L back-up plate.

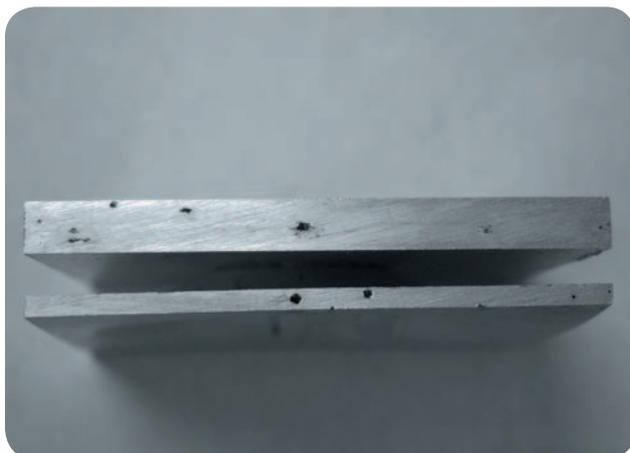
**Fig. 6** Severe pitting on edges of the 316L back-up plate and 316L dimple jacket

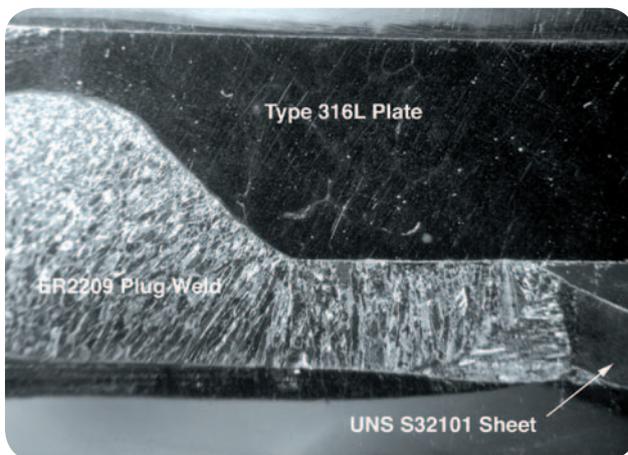
Fig. 7 Typical cross section of a S32101 dimple jacket welded to a S31603 plate utilizing ER 2209 weld filler.

The microstructures of the plug welds used to fabricate the S32101 dimple jackets were evaluated by examining cross sections cut through the center of the plug welds. Metallographic specimens were prepared using standard polishing techniques and specimens were etched using an electrolytic sodium hydroxide etch as outlined in ASTM A 923 Test Method A. Figure 7 shows a typical cross section of a ER2209 plug weld. The microstructure of the S32101 base metal is presented in Figure 8 and the Heat Affected Zones (HAZs) for

The weld cross sections show very good weld penetration and no welding or fabrication defects were observed on any of the samples. The cross sections show that there is a 'notch' or crevice created in the vicinity of the plug weld where the dimple jacket sheet is joined to back-up plate. This is inherent in the design of embossed dimple jackets and may be a factor in promoting SCC and crevice corrosion failures. This notch can also concentrate stress and be a possible factor in fatigue failures.

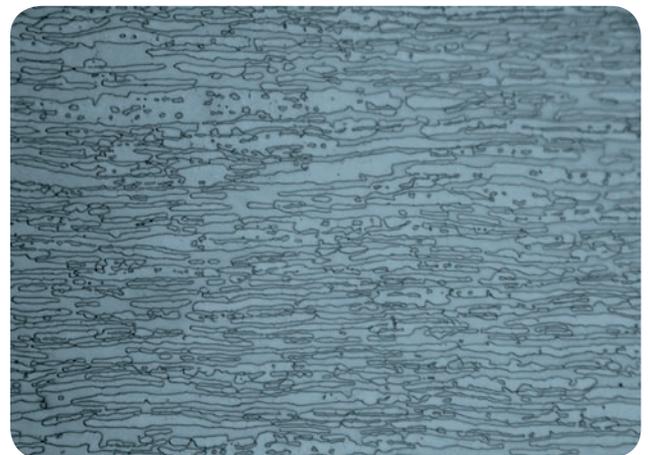
Fig. 8 Typical microstructure of the S32101 sheet (mag. = 400X)

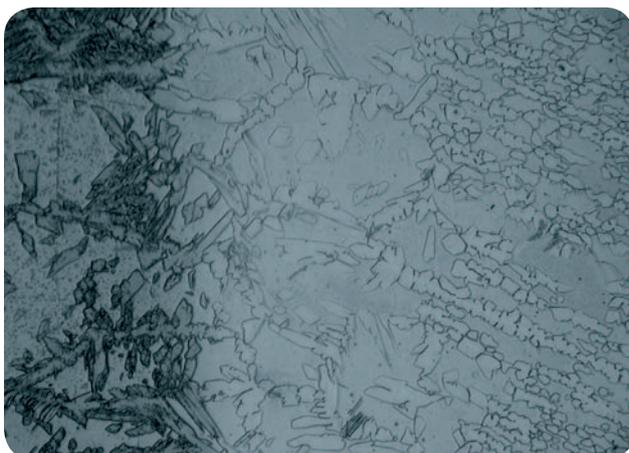
Fig. 9 Microstructure of weld and S32101 HAZ for a ER2209 plug weld using a shielding gas of 75% Argon / 25% Helium (mag. = 200X)

ER2209 plug welds using a shielding gas of 75% Argon / 25% Helium and 69% Argon / 30% Helium / 1% Nitrogen mixtures are presented in Figures 9 and 10, respectively. The use of an ER316L filler to attach the S32101 dimple jacket to a type 316L plate was also evaluated and a typical cross section of the S32101 and HAZ zone microstructure are shown in Figures 11 and 12.

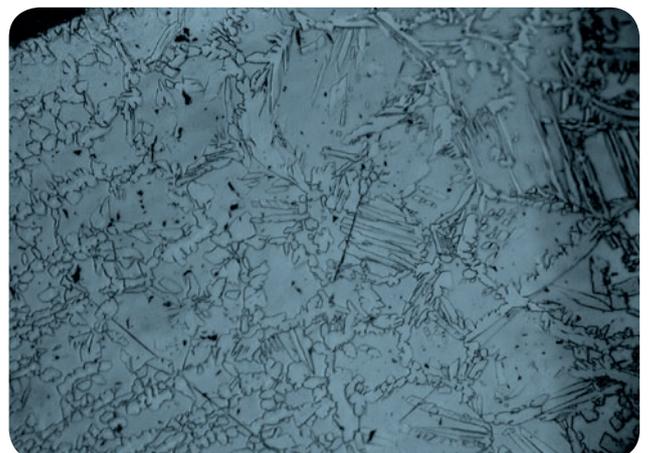
Fig. 10 Microstructure of weld and S32101 HAZ for a ER2209 plug weld using a shielding gas of 69% Argon / 30% Helium / 1% Nitrogen (mag. = 200X)

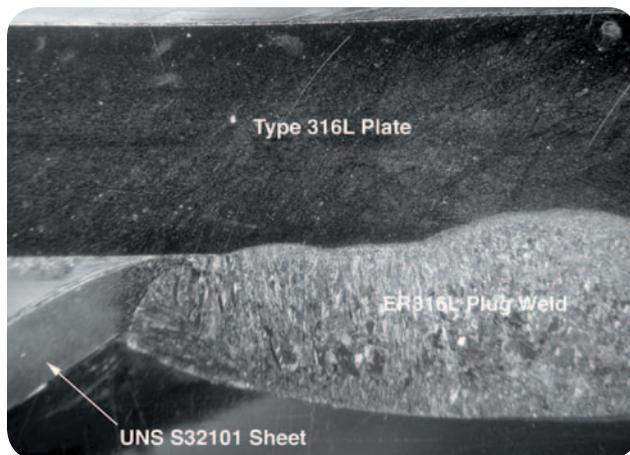
Fig. 11 Typical cross section of a S32101 dimple jacket welded to a 316L plate utilizing a ER316L weld filler.

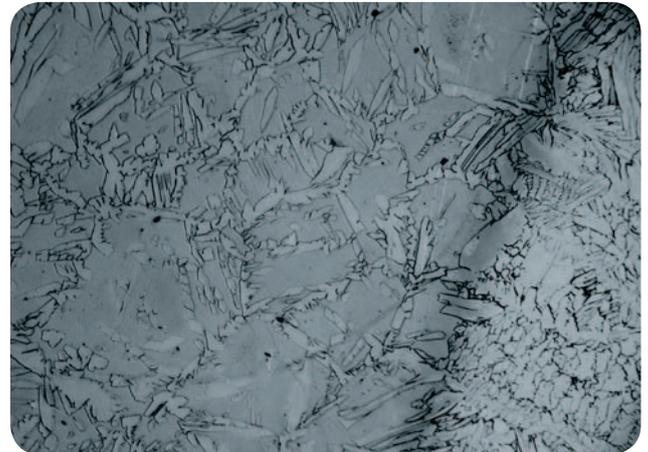
Fig. 12 Microstructure of weld and S32101 HAZ of a ER316L plug weld using a shielding gas of 75% Helium / 25% Argon (mag. = 200X)
